Chesapeake Tartan 30 Association

TARTAN 30 STARBOARD CHAINPLATES

Brad Armendt, *T-30 #282, Emprise*, May 1998*

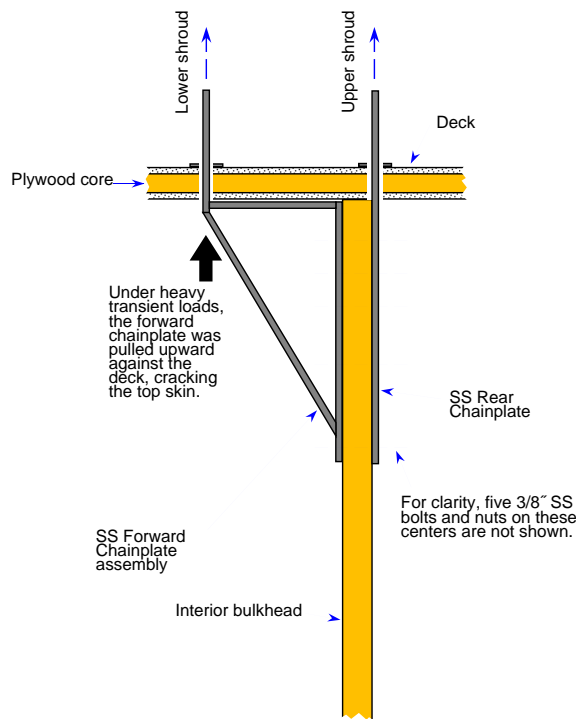
FIGURE 1. Original Installation.

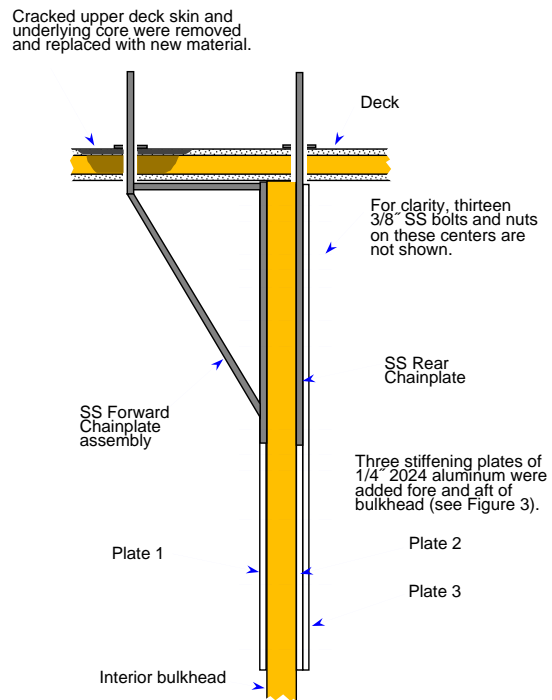
I also had a problem with my starboard chainplate on *Emprise*. I thought at the time (probably about 1980) that I had neglected to keep the chainplate properly caulked, and that water had gotten through and perhaps softened the bulkhead that the chainplate is bolted to. From close examination of the cracking of the deck above, it seemed that the chainplate had rotated upward when under load, so that it cracked the deck around the forward (lower shroud) part of the chainplate (see Figure 1). When sitting in the slip, with no sailing loads on the rig, the chainplate looked perfectly normal, and did not press upward against the deck at the front.

FIGURE 2. Repair circa 1980.

I removed the chainplate and did my best to saturate the bolt holes and the area of the bulkhead near the chainplate with a very low-viscosity penetrating epoxy called Boatlife Git Rot (which is still available). The idea was to seal the wood and restore as much strength as possible, if rot had occurred. After this cured, I replaced the chainplate but laminated it with three plates of 1/4 inch thick 2024 aluminum, one forward of the bulkhead and two aft of it (Figure 2). The 1/4 inch plates were 3 inches by 19 inches. The plate on the forward side and one on the aft side had a 1 1/2 inch by 10 inch notch cut out of one corner, so that they fit around the stainless steel chainplates (Figure 3). The original five stainless steel bolts (3/8 inch in diameter) were replaced with similar but longer bolts which passed not only through the chainplate and bulkhead, but also the aluminum plates. In addition, I put eight more of these stainless steel bolts through the length of the aluminum plates and the bulkhead, down almost 19 inches below the deck. Thus, in addition to the load carried by the chainplate to the bulkhead by the original five bolts, the eight additional bolts carried load to a much larger area of the bulkhead, well away from the area that I thought might have softened. And I thought the three 1/4 inch thick aluminum plates should greatly stiffen the area near the chainplate attachment.

The upper deck and core around the lower shroud chainplate was excavated over about a four-inch circle (leaving only the bottom fiberglass skin of the deck); I had the boatyard repair the hole and spray gelcoat over the top.

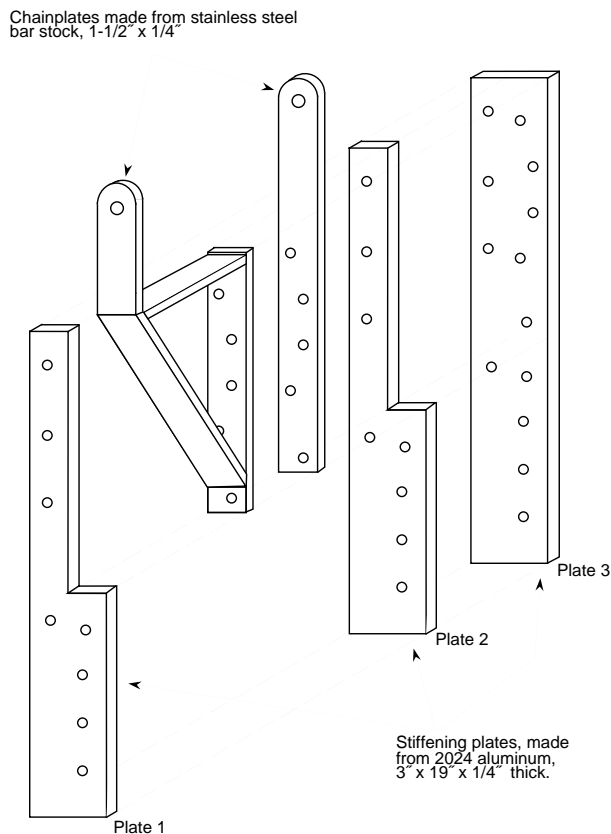
FIGURE 3. Exploded View of Chainplates and Stiffening Plates Used in 1980 Repair (Deck, bulkhead, bolts & nuts not shown)

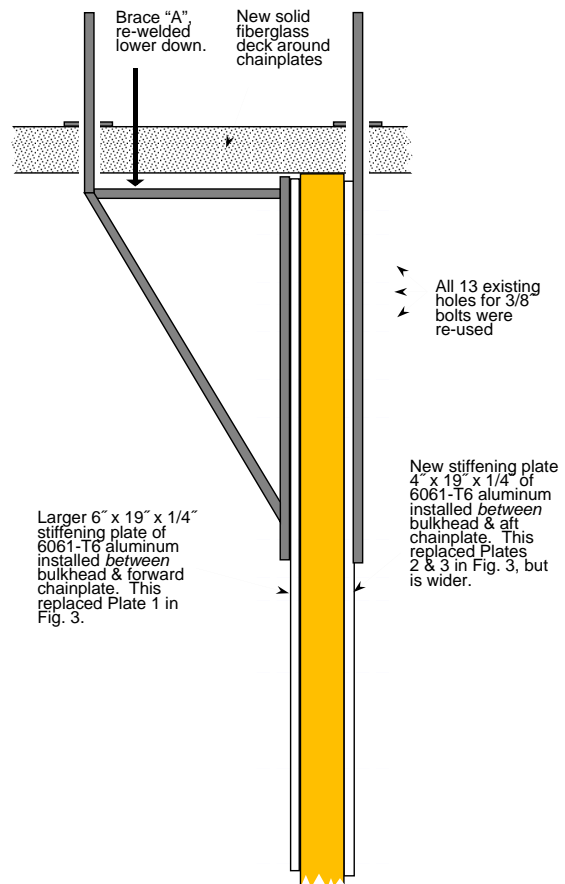
Did that work? Well, after perhaps 15 more years of sailing, including some hard racing and more than a few storms, the chainplates still seemed solid and tight. The area around the forward (lower shroud) chainplate that was repaired with fiberglass showed some fine cracks radiating from the chainplate, but I think they were mostly in the gelcoat; they were not visible on the bottom of the deck. I now think what happens is that under occasional *heavy* load the whole boat flexes and the horizontal brace part of the forward SS chainplate pushes upward against the deck, causing the cracks.

FIGURE 4. Second Repair, Feb 1998 (enlarged view)

During the winter of 1997-98 we put our boat in the yard for an AwlGrip paint job and some other renovations. This required removal of ALL hardware and teak from the cabin, deck and topsides, except the teak toerails. The port chainplates were left in and masked for the painting, but the starboard ones were removed. The core of the deck around the starboard chainplates was found to be watersoaked, so the top fiberglass layer of the deck and the plywood core was removed over an area about two feet in diameter. In most of this area the plywood core was replaced with fairly dense closed cell foam, but the area within several inches radius around the chainplates was replaced with solid fiberglass. Then the top fiberglass layer of the deck was relaid. After this was finished, you cannot see that any repair

While we had the starboard chainplates out of the boat, the forward one (for the lower shroud) was modified. The horizontal brace was cut out and rewelded about $\frac{1}{2}$ inch lower down (see Figure 4). This will provide some additional room for the boat to flex under heavy transient loads without forcing the horizontal brace up against the bottom of the deck. The old stiffening plates (of soft 2024 aluminum) were discarded, and two new and somewhat larger plates made of stronger, stiffer 6061-T6 aluminum were installed. The forward one between the forward chainplate and the plywood bulkhead was 6 inches wide by 19 inches high. The aft plate, installed between the bulkhead and the aft chainplate was 4 inches wide by 19 inches high. Both new stiffening plates were $\frac{1}{4}$ inch thick. The idea of the new plates was to broaden the load-carrying area as much as possible and to eliminate a potential “hinge point” at the bottom of the forward chainplate. The dimensions of these new reinforcing plates were, basically, as large as could be managed *without* requiring surgery on the nearby fiberglass liner to gain more access. The $\frac{1}{4}$ inch displacement of both chainplates (one forward, one aft) caused by insertion of the new reinforcing plates was no problem because the deck repair (described above) closed both chainplate holes; new chainplate holes through the deck were cut where needed. But if the chainplate modifications had been done *without* the concurrent deck repair, it would have been a simple matter to enlarge the holes through the deck to allow for the chainplates’ displacement of $\frac{1}{4}$ inch, and then patch the holes with a little fiberglass resin to reduce them to the desired size.
