Chesapeake Tartan 30 Association

FORESTAY FITTING FAILURE

STRENGTHENING THE STEM FITTING

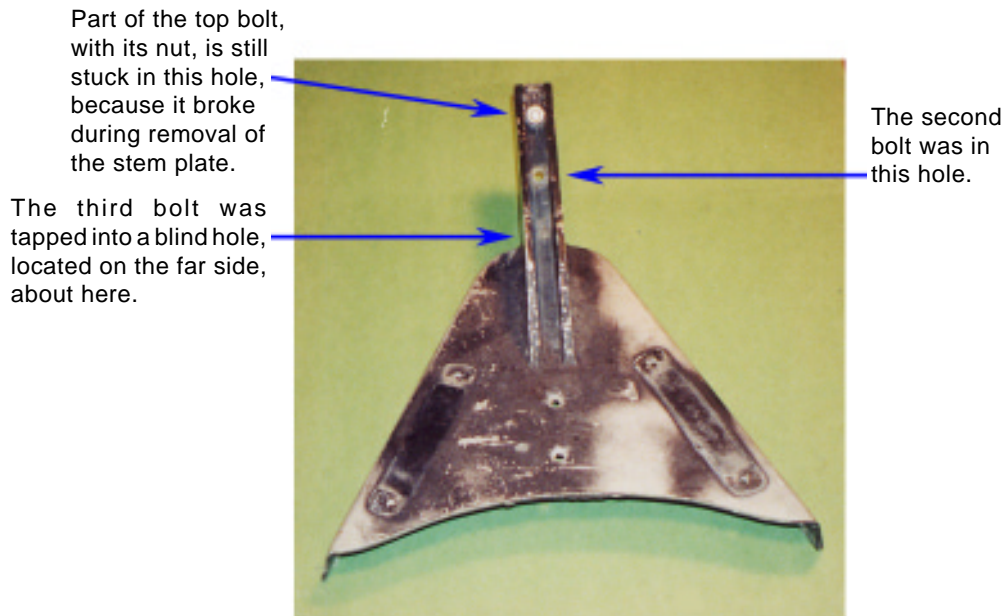
(Illustration added February 2001)

I'm glad I did, because I also found corrosion had eaten away about half of the thread depth in the aluminum plate (the bolts were as good as new, though). I only replaced the top two bolts, because the third bolt down is tapped into a blind hole in a place where it's not practical to drill it all the way through. It turned out to be a fairly tough job because the corrosion, while weakening the aluminum, also froze the bolts so they were difficult to get out. These are large flat-head bolts with a slotted head. The top bolt was finally loosened by soaking in penetrating oil, and considerable pounding with an impact wrench. The second bolt was immune to the impact wrench, and finally had to be drilled out. I started with a $\frac{1}{8}$ " drill bit and drilled all the way through the length of the bolt. Then the hole was gradually enlarged using progressively larger drill bits until the tap drill size was reached. The remainder of the bolt was removed with a $\frac{3}{8}$ " tap. This procedure is necessary because if you start with a large drill bit it will usually veer off of the stainless bolt into the softer aluminum alongside. Stainless steel should always be drilled slowly, e.g., with a variable-speed drill run at low speed. Removing this one screw took about two hours.

This is the cast aluminum stem plate removed from *Emprise* in 1997, when it was replaced with a new stainless steel stem plate with anchor rollers.

Once the screws were removed and the threaded holes in the stem plate were cleaned by re-tapping, slightly longer bolts were installed and set hard using the impact wrench. Stainless nuts were then installed on the bolts. The slot in the stem plate is barely wide enough for the nuts to turn, but not wide
