Chesapeake Tartan 30 Association

UPGRADING THE TRAVELER

Lee Greenbaum, T-30 #90, *Cloudsong*, October 1996*

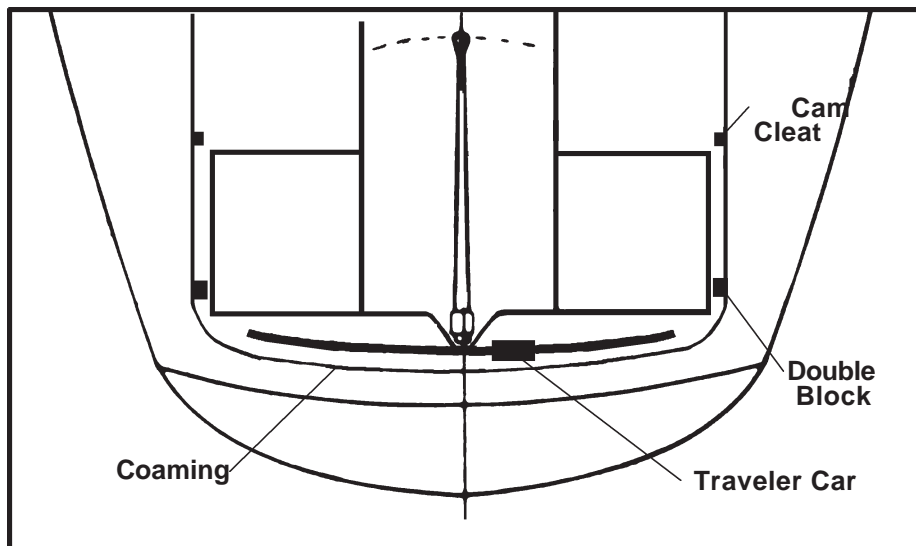
I finally bit the bullet and replaced the old system with a new track, ball bearing car and a line system with a mechanical advantage of three. The new track was mounted on the original canted teak base, but after it was mounted I realized that I should have moved the teak base forward to the edge of the molding. This would have allowed the car to move the entire length of the track without being stopped by the vertical fiberglass molding. As it now stands I lose about one inch at each end, but I feel that is not serious enough to justify drilling twelve more holes in the boat and moving it forward.

The components of the new system were recommended by Fawcett Boat Supplies, Inc., an Annapolis yacht chandler. Unfortunately, the double blocks at the ends of the track that were recommended by Fawcett's had cam cleats that extended forward, which prevented opening or closing the lazarette hatches. Therefore I had to mount double blocks and cam cleats on the vertical surfaces of the coaming to provide clearance for access to the lazarettes. The individual parts used are listed below.
