Chesapeake Tartan 30 Association

UPGRADING THE TRAVELER

Lee Greenbaum, T-30 #90, *Cloudsong*, October 1996*

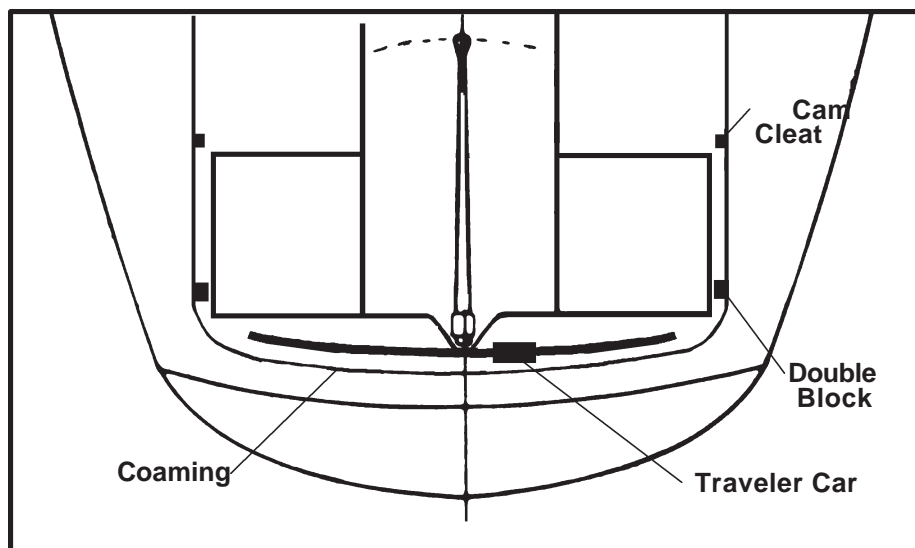
One of the major problems with the original track was that, to move the traveler, one had to move the traveler stops by pulling up on the locking pins. When the traveler was under a load in moderate to heavy airs, it was necessary first to move the car to windward or ease the sheet to take tension off of the stop, so that the pin could be pulled up to unlock the stop. This was quite slow and inconvenient.

I finally bit the bullet and replaced the old system with a new track, ball bearing car and a line system with a mechanical advantage of three. The new track was mounted on the original canted teak base, but after it was mounted I realized that I should have moved the teak base forward to the edge of the molding. This would have allowed the car to move the entire length of the track without being stopped by the vertical fiberglass molding. As it now stands I lose about one inch at each end, but I feel that is not serious enough to justify drilling twelve more holes in the boat and moving it forward.

The components of the new system were recommended by Fawcett Boat Supplies, Inc., an Annapolis yacht chandler. Unfortunately, the double blocks at the ends of the track that were recommended by Fawcett's had cam cleats that extended forward, which prevented opening or closing the lazarette hatches. Therefore I had to mount double blocks and cam cleats on the vertical surfaces of the coaming to provide clearance for access to the lazarettes. The individual parts used are listed below.

Quantity	Harken Part No.	Description
1	1510	Mid-range traveler track, bent to shape by Harken
1	1508	Mid-range traveler car with single control blocks w/becket
2	1514	
2	220	Double upright lead blocks
2	356	Cam-Matic cleats w/fairlead
